Three-Point bending tests Of Zirconia Core/Veneer ceramics for Dental Restorations.

Introduction. The mechanical strength and the surface hardness of commercially available yttrium doped zirconia were investigated. Furthermore, a comparative study of eight different ceramic veneers, to be used for the production of two-layered all-ceramic restorative systems, was carried out.

Materials and Methods. Four types of zirconia specimens were analyzed, according to a standard ISO procedure (ISO 6872). Besides, two-layered zirconia/veneer specimens were prepared for three-point bending tests.

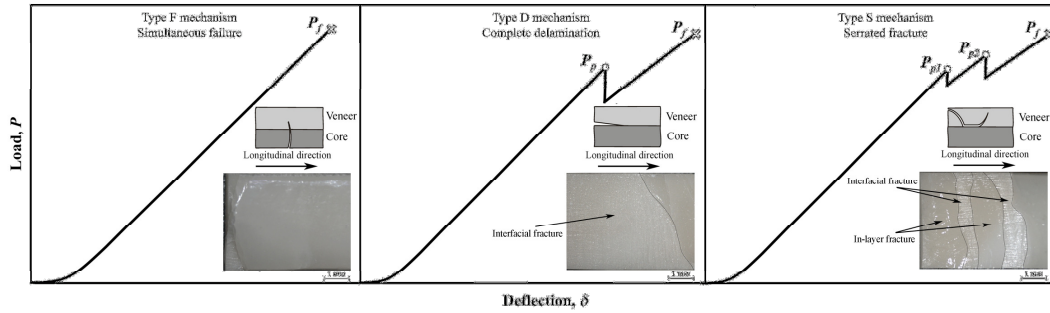
Figure 1: Failure mechanisms of the two layered zirconia-veneer specimens together with schematic depictions of the force-deflections curves and optical observations of the fracture surfaces.

Ten two-layered specimens for each veneering ceramic were analyzed by three-point bending tests. Three different failure mechanisms have been observed as shown in Fig. 1:

- a) simultaneous failure of zirconia and veneer (Type F);
- c) complete interfacial debonding of the veneer (Type D);
- b) serrated fracture of the ceramic veneer (Type S), *i.e.* the crack spreads in the veneer, approaches the zirconia-veneer interface and then kinks again into the veneer.

In particular, Fig. 1 illustrates schematic depictions of the force-deflection curves for the three observed failure mechanisms, and optical observations of the fracture surfaces are also given. The figure shows that a monotonic force-deflection curve is obtained when the simultaneous failure of zirconia and veneer occurs at failure load P_f (Type-F). In this case, the crack, initiated in the zirconia substrate, was only able to extend in the veneer, and interfacial fracture did not occur. It is therefore believed that the material systems which consistently showed this failure mechanism were characterized by stronger interactions at the veneer/zirconia interface. On the other hand, non-monotonic curves with one or multiple intermediate peaks at the load P_{pi} were also observed, and classified as Type-D and Type-S mechanisms. In both cases the crack was able to deflect at the zirconia/veneer interface, and therefore interfacial failure did occur. However, while for Type-D the deflected crack proceed all the way long the interface, for Type-S it oscillated between the interface and the veneer. The reason for this behavior could be addressed to the relative proportion of interfacial to veneer fracture toughness. Indeed, for a tougher veneer the deflected crack could be entrapped at the

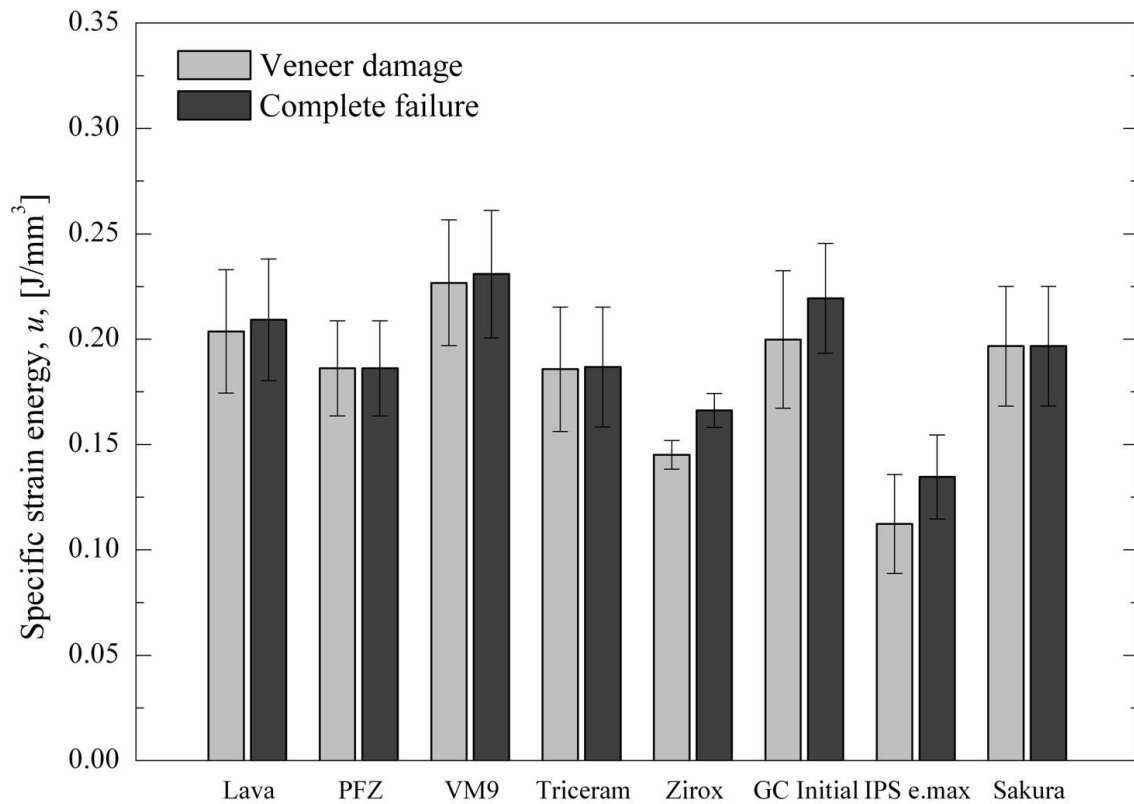
Figure 2: Strain energy per unit volume at failure and veneer damage for the two-layered specimens.

In Fig. 2, the strain energies per unit volume of the two-layered specimens, which have been obtained from the experimentally measured force-deflection curves, are compared. In particular, the figure shows the total strain energy at failure ($u_{tot f}$), *i.e.* when $P=P_f$, as well as the strain energy at specimen damage $u_{tot p}$, *i.e.* for $P=P_p$. It is worth noting that the first peak load is considered to calculate $u_{tot p}$ when the load displacement curve has multiple peaks, *i.e.* in the case of serrated fracture. (**Fig. 2**)

Figure 2 shows that Vita VM9 ceramics provide the best mechanical behavior; the figure also shows that Ceramco PFZ and Sakura Interaction veneers have the same values for the two energies, $u_{tot f}$ and $u_{tot p}$, as a consequence of simultaneous failure of zirconia and veneer. Finally, IPS e.max, GC Initial ZR and Zirox veneers show marked differences between $u_{tot f}$ and $u_{tot p}$ as a consequence of an early damage of the ceramic coating, due to complete delamination or fracture.
